TECHNICAL BULLETIN

CLUB LOTUS

ELAN DISTRIBUTOR - ADVANCE

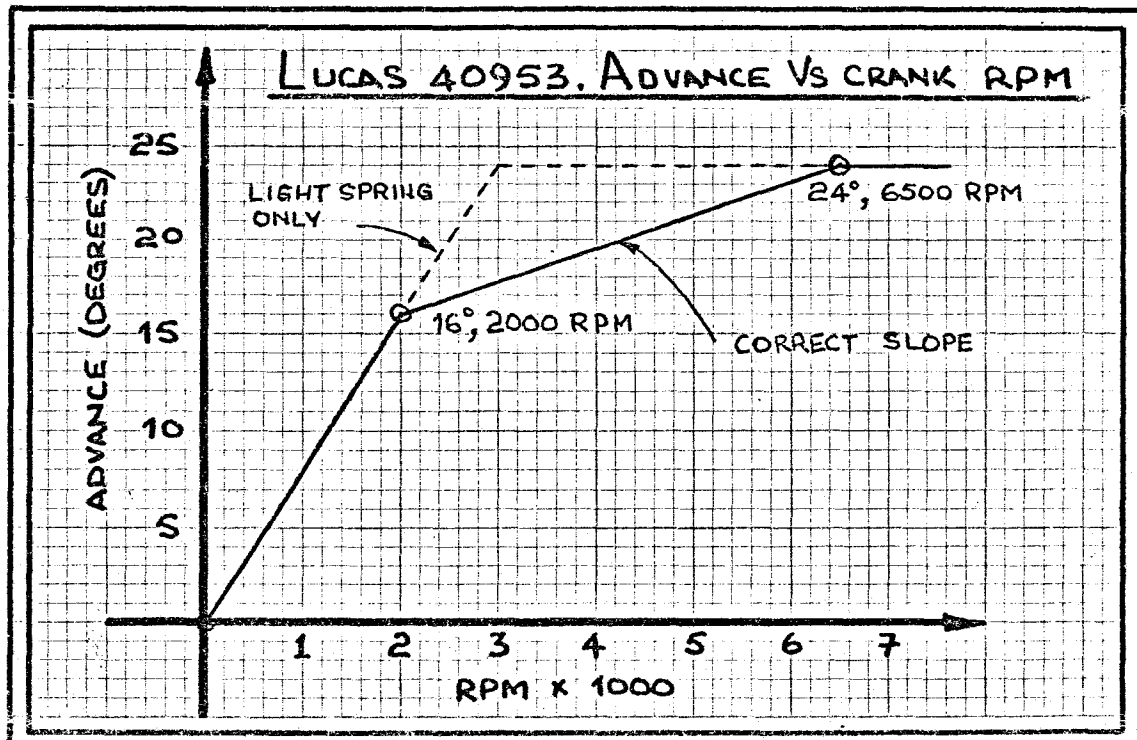
This Technical Bulletin refers to distributors with Despatch No. 40953, which if you have Webers then this is the distributor that will be fitted. The diagram overleaf shows a graph of crankshaft rpm vs ignition advance related to crankshaft position. This graph is plotted directly from the figures given in the manual, except that I understand that the advance for 5000 rpm should be 21.3 degrees, and for 5500 rpm it should be 22.2 degrees.

There are three portions to be considered. The first (steep) slope is taken care of by the light advance spring. The two springs are simply called light and heavy, and at the time of writing are no longer available. The graph shows that in only 2000 rpm the ignition advances by 16 degrees, that is two-thirds of the total advance available before the distributor plate (which should be stamped 12 degrees) hits its stop pin. At 2000 rpm the heavy spring, which has an elongated eye, starts to stretch, which slows down the rate of advance. Note that if the heavy spring were not there maximum advance would be reached at about 3000 rpm. Both springs are now being stretched by the centripetal force acting on the bob weights. The flat bit of the graph won't be used when the distributor is fitted in the car unless the motor is run past 6500 rpm. The other point to be made is that the distributor only advances 12 degrees, but because of the gearing (2:1) the ignition advances by twice that amount. Don't let anyone tell you any different.

The linear movement of the distributor plate, in a circular manner if you see what I mean, is quite small, about 0.199 inches. The amount by which the plate moves against the heavy spring is 8 degrees out of 24 i.e. $\frac{1}{3}$ of 0.199 = 0.0663 inch. Further, the spring acts diagonally, reducing its stretch to about 30 or 40 thou, difficult to measure so I can't be more precise.

Now we have an explanation of the pinking problem. The springs are quite fiddly to remove, and the hooks are soft. It is very easy to accidentally open the heavy spring hook when removing or replacing it, and it only needs to be opened by 30 or 40 thou or stretched slightly and it will do nothing to stop the ignition advancing to 24 degrees at 3000 rpm. Hence the pinking.

You can send the distributor to Lucas to be calibrated, at a cost of £10 upwards, depending on what else they find wrong with it, but it is relatively easy to adjust in the workshop as follows: Remove both springs, check that the total travel of the plate is

in the order of 0.2 inch. There is no reason why this should not be correct. Replace the heavy spring only. Grip the main shaft carefully in a vice and rotate the plate until the spring is tight but not stretched. Measure the gap between the plate and the stop pin. This should be 66 thou. If not, the hooks can be crimped carefully until the dimension is correct. Replace the light spring, refit the distributor to the engine and check the advance against the graph.
