A broken connecting rod assembly was analyzed and compared with an intact assembly from a different cylinder in the same engine. It was concluded that the materials were not defective or inferior. The failure resulted from a delayed fatigue fracture.

William G. Morris  
Research Metallurgist  
General Electric Research and  
Development Center

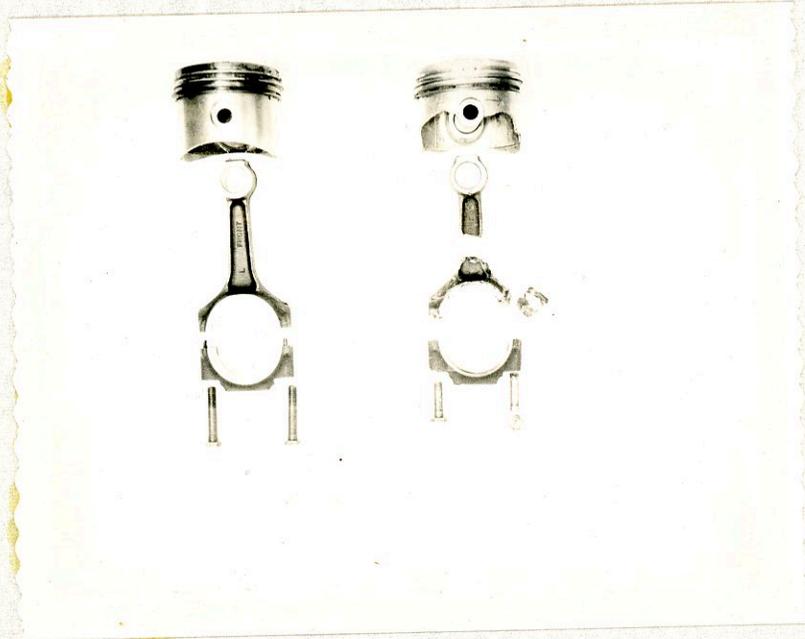
FIGURE I

The no. 4 and no.1 connecting rod assemblies  
from the Lotus Elan Engine.
