Replacing the lower hinge cup bobbins – 1966 Elan S2

A method described by Sue Miller in her document “Small tips to enhance you Elan” that was supplied with her parts list (www.mickmillerlotus.com) and put into practice here by Paul Haigh

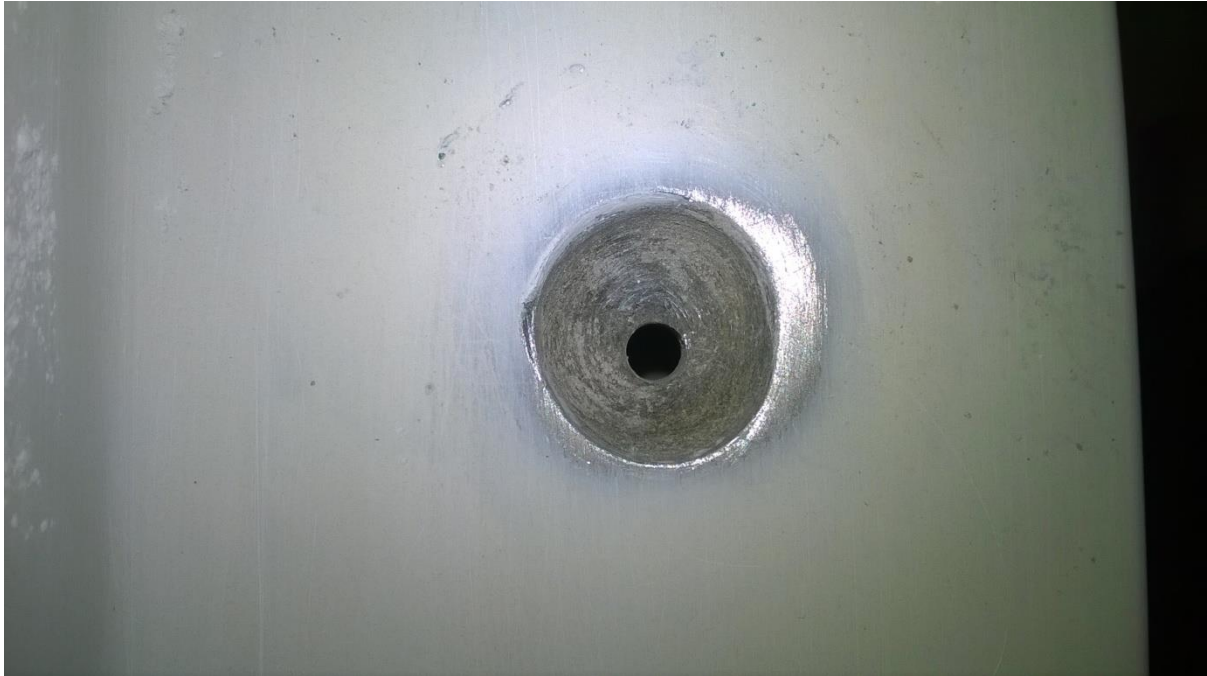
Old bobbins are badly worn. Drivers side:
